**Town of Starks**  
57 Anson Road  
Starks, ME 04911

RE: Project No. 201601017- 2016 Grants for Stream Crossing Public Infrastructure Improvements

<b>Maine Department of Environmental Protection</b> <b>Request for Proposals for Stream Crossing Public Infrastructure Improvement Projects</b> <b>Proposal Application Form - 2016</b> <b>RFP# 201601017</b>			
<b>I. Applicant Information</b>			
Applicant Name			
Town of Starks			
Address	Town	State	Zip
57 Anson Road	Starks	Maine	04911
Applicant Phone #	Applicant Email Address

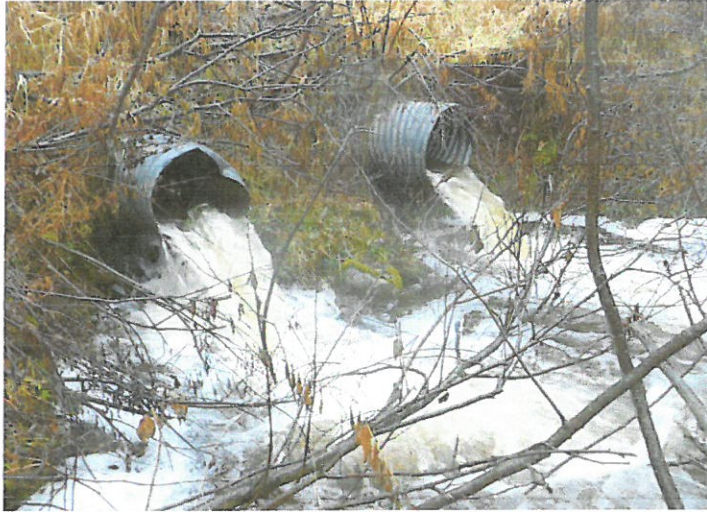
Culverts during spring runoff. Note the 2 to 3 foot drop into the plunge pool.

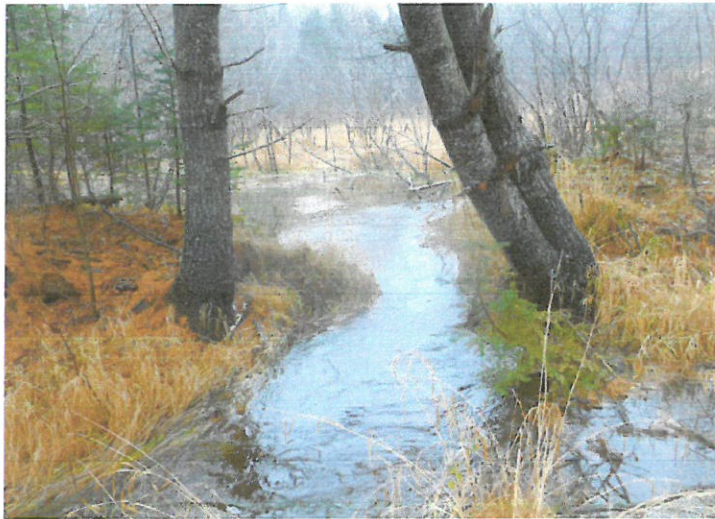
Looking into the upstream wetland during spring 2016 runoff. Water exiting wetland through a breach through an old apparent berm.

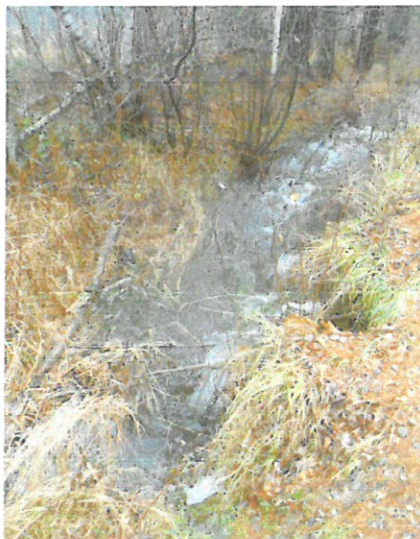
Upside ditch carrying diverted /excess spring runoff down along road ditch to floodprone area. Water exit from wetland is above, culvert entrances are below.
